Holloway Green Street Annual Monitoring Report 2017-2018

Holloway Green Street Annual Monitoring Report 2018-2019

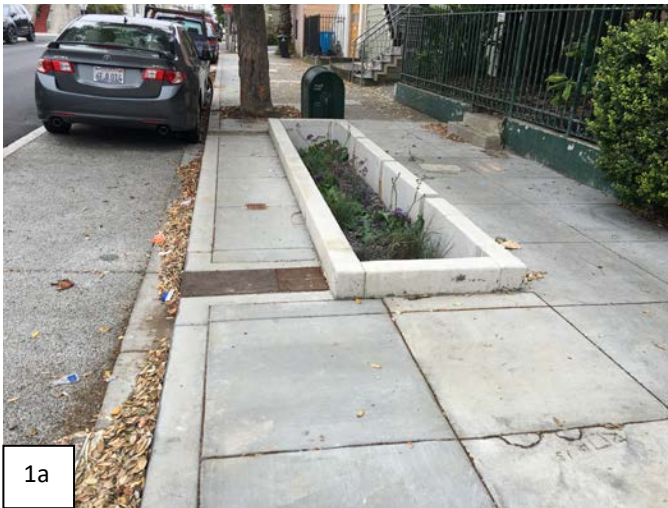
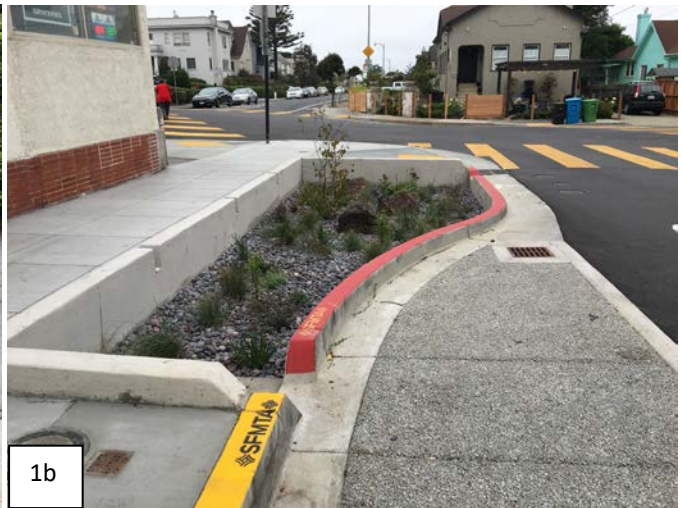
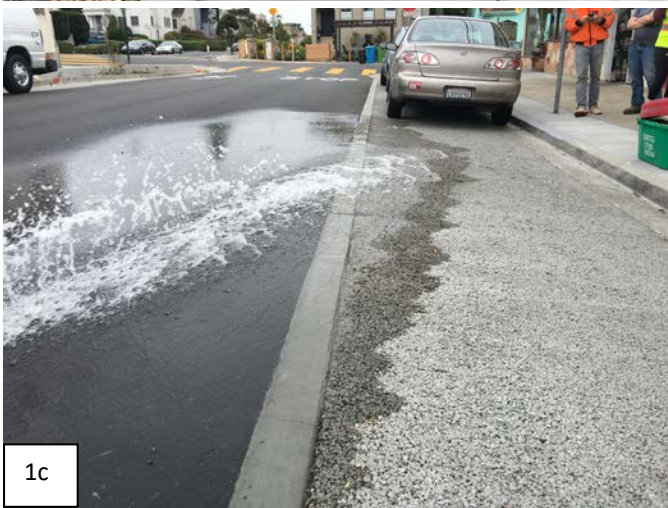
Figure 1a, 1b and 1c: A mid-block sidewalk planter, end-of-block bulbout planter, and pervious concrete.

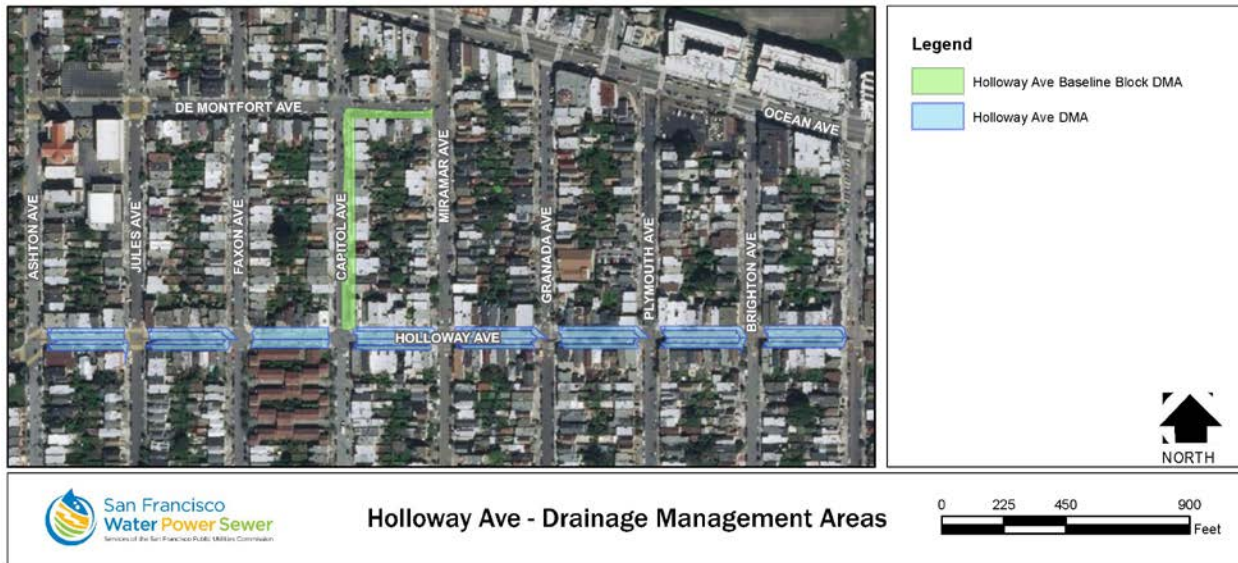
Figure 3: Location of the baseline block relative to the project area

Figure 3 shows the spatial relationship between the baseline block and the project area.

Table 1 provides the DMAs for both the baseline block and the monitored blocks, as well as the sizing ratio for the GI technologies. The baseline block DMA is larger than the project block DMAs because it is located on a corner where the two intersecting streets both drain to the catch basin. The DMAs were delineated using the subcatchment layer from the City and County of San Francisco (CCSF) Hydrologic and Hydraulic model and were then adjusted according to field observations of drainage patterns during wet conditions.

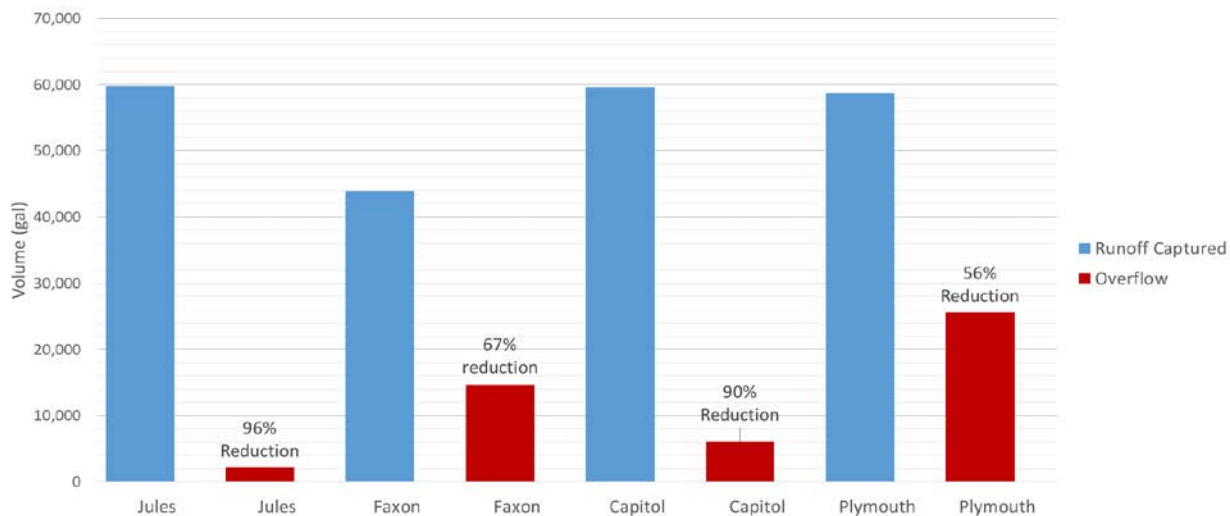
Overflow from the monitored blocks was significantly less than the baseline flow for all blocks. Measured across the whole rainy season, monitored volume reduction ranged from 56%-96% with an average 77%. Performance is strongly correlated to infiltration rate with the best performance at the western end of the project and generally decreasing to the east. The SWMM model was in general agreement with the monitoring results, estimating that GI reduced runoff volume by 75% across the four monitored blocks, and by 70% across the full project area. According to both the monitoring results and the supporting modeling results, the overflow from the Model Block was significantly less than the baseline flow during the 2017-18 monitoring period (Figure 8).

Figure 4: Monitored block performance for the 2017-2018 monitoring period.

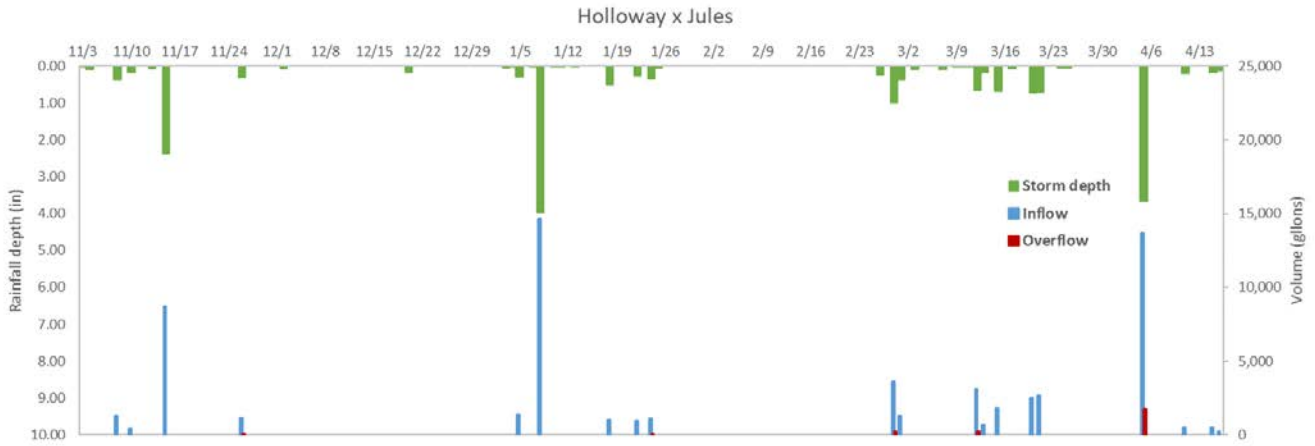
Figure 6: Hydrograph showing inflow and GI overflow of the 2017-2018 Monitoring Period at Holloway x Jules

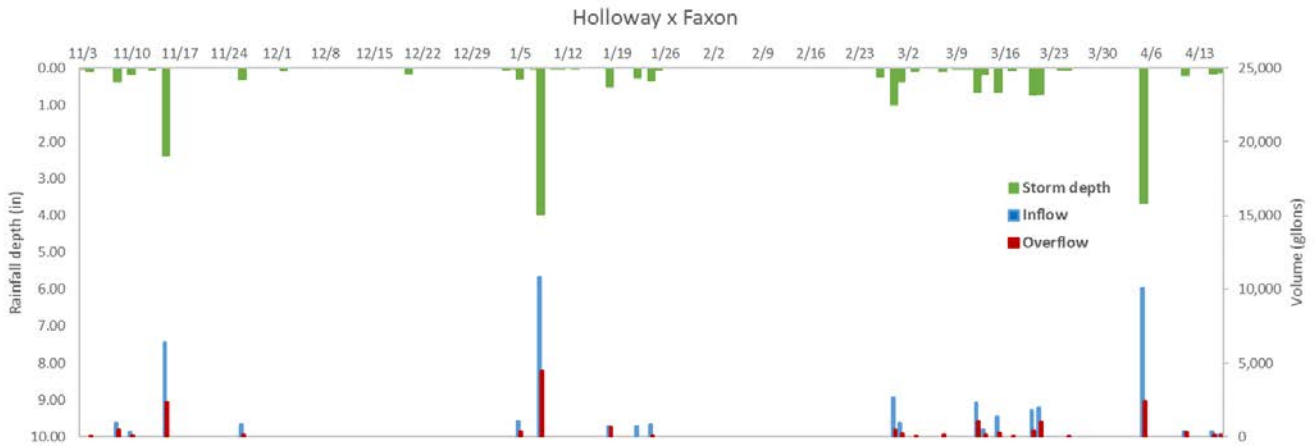
Figure 7: Hydrograph showing inflow and GI overflow of the 2017-2018 Monitoring Period at Holloway x Faxon

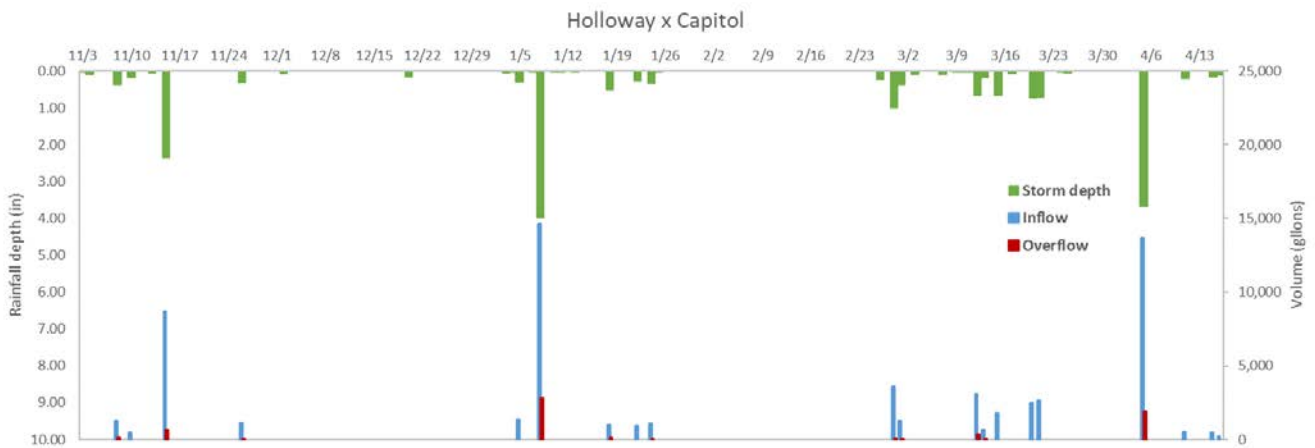
Figure 8: Hydrograph showing inflow and GI overflow of the 2017-2018 Monitoring Period at Holloway x Capitol

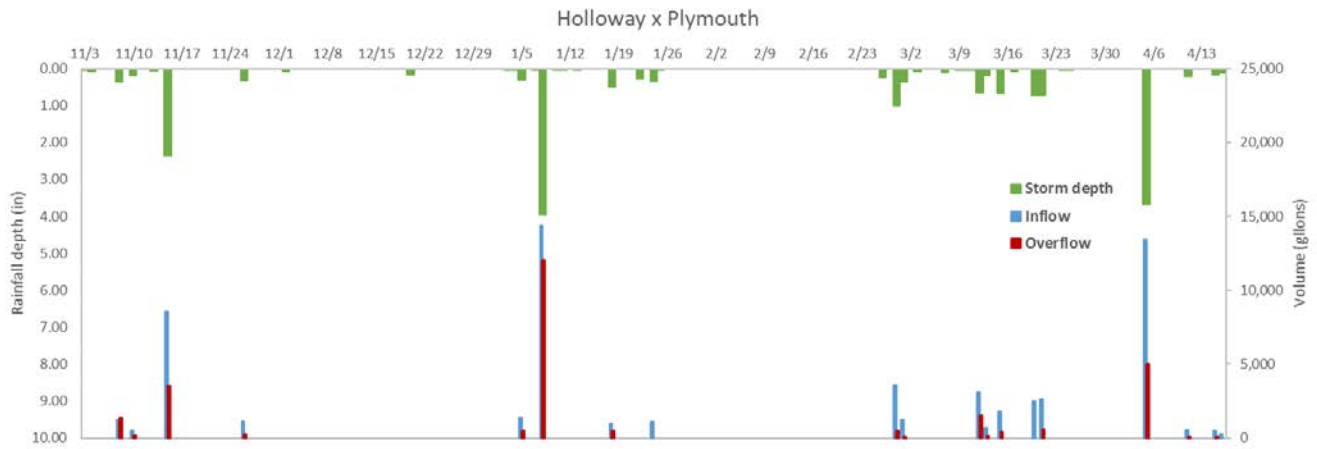
Figure 9: Hydrograph showing inflow and GI overflow of the 2017-2018 Monitoring Period at Holloway x Plymouth

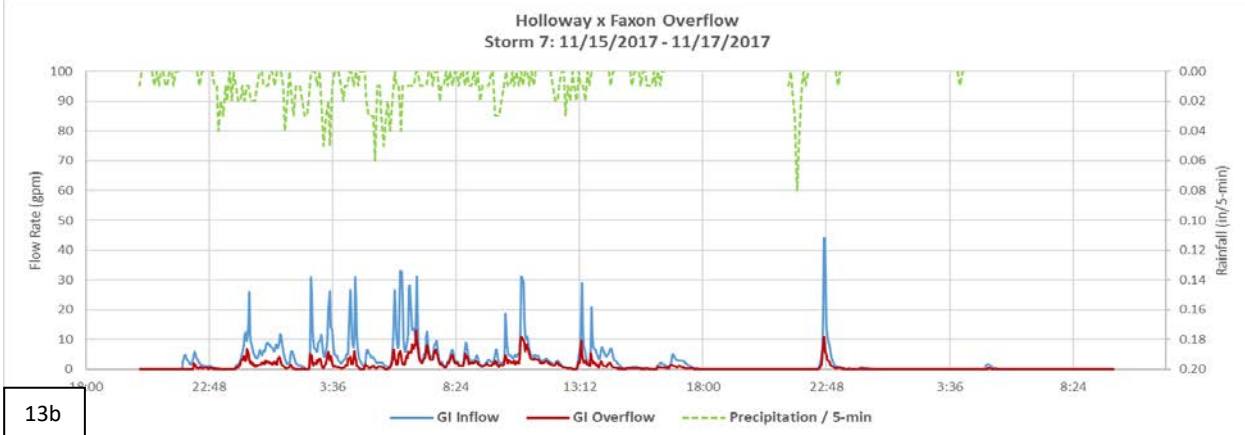
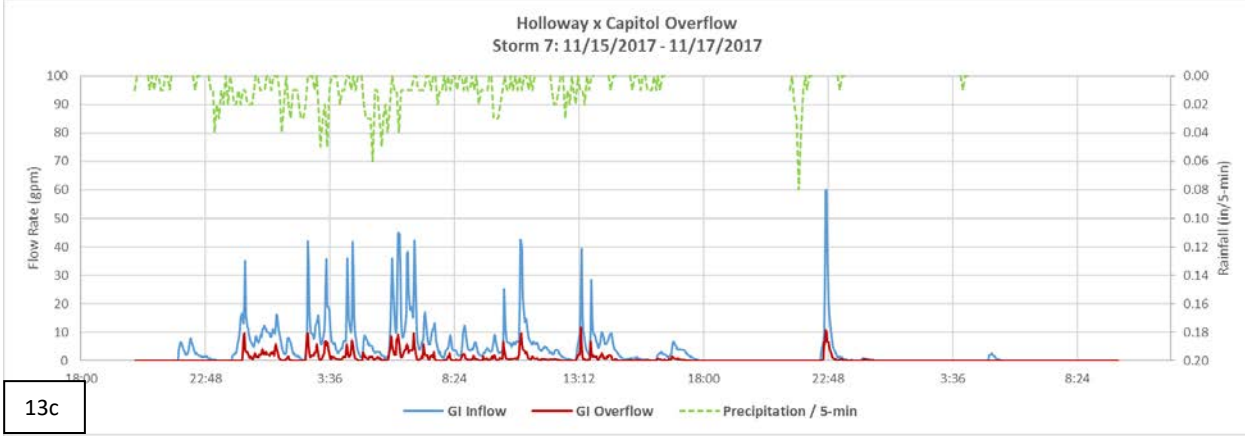
Figure 14 shows the hydrographs for a large storm event, Storm 7, which produced 2.36 inches of rainfall over the course of 32 hours from the evening of November 15th to early morning of November 17th, 2017. This was the first large storm of the season, and the dry soil appears to have been more absorbent than later in the rainy season. There was a wide range of monitored performance across the four blocks during this storm. Holloway x Jules fully managed the storm while Holloway x Plymouth reduced volume by 59% with no effective peak flow reduction. The data show that less intense periods of rainfall were mostly or fully managed on all blocks. Peak flows during intense bursts of rainfall were dampened to a fraction of baseline flows at the three infiltrative blocks, while the underdrained block at Plymouth became fully saturated and entered a flow-through condition during these periods. There was a dry period of over five hours prior to the final burst of rainfall, which allowed facilities on the infiltrative blocks to regenerate storage capacity and absorb most or all runoff from that burst; Plymouth was still fully saturated and provided no effective management during that final burst.

Figure 10: Hydrographs for large Storm 7 at Holloway x a) Jules, b) Faxon, c) Capitol, d) Plymouth

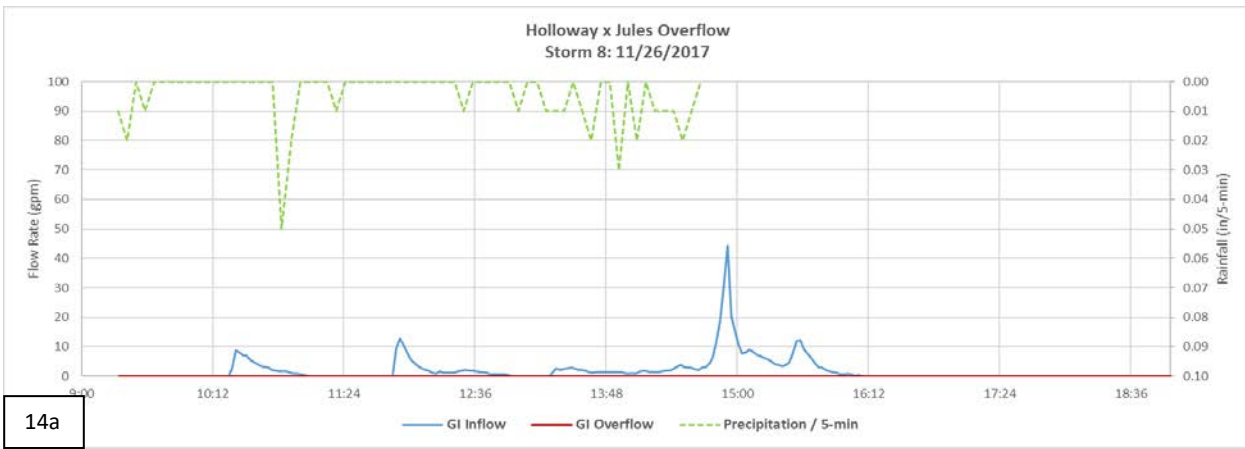
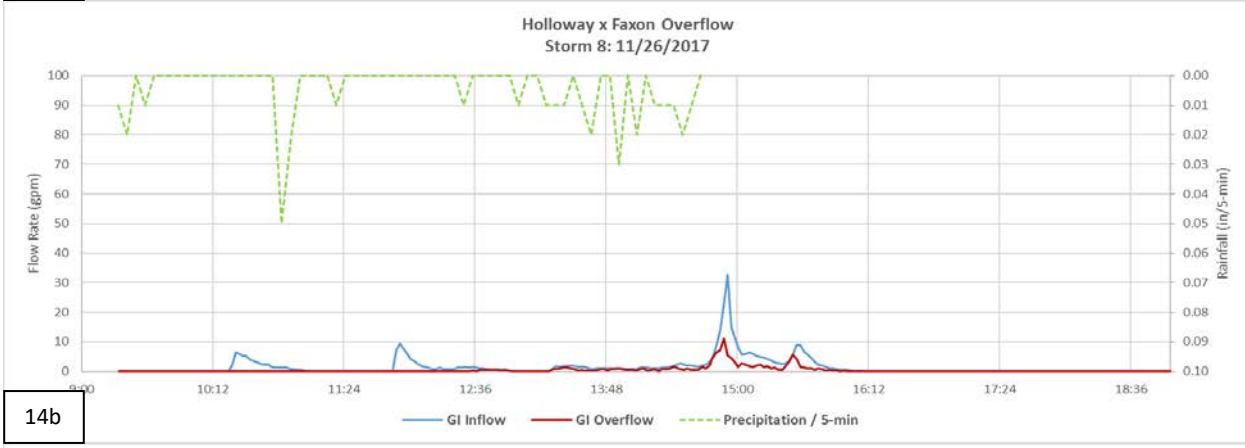
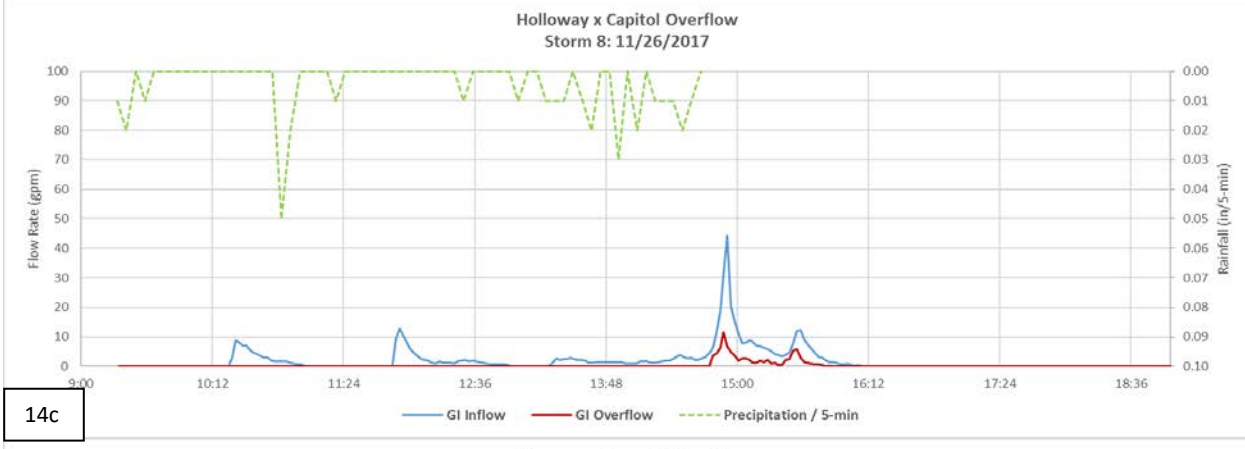
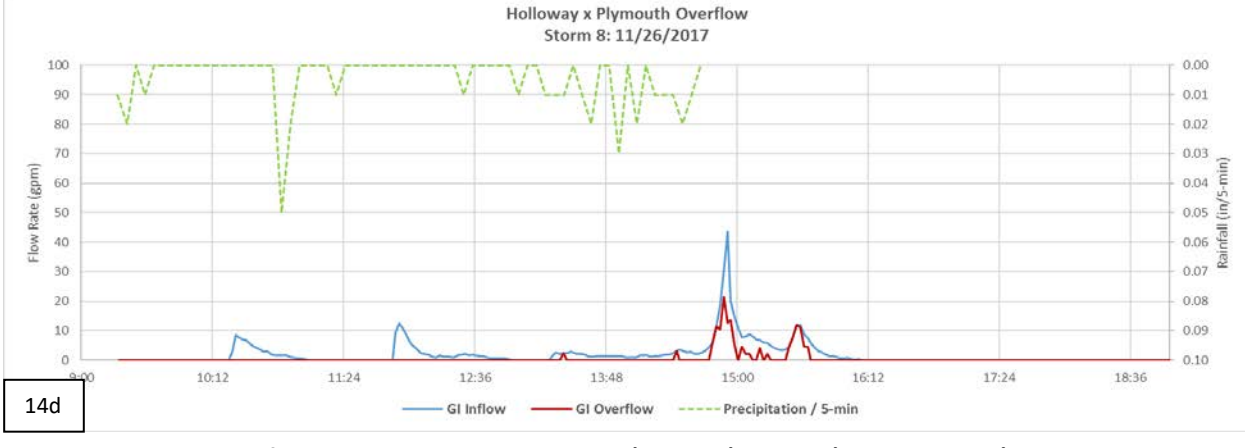
Storm 8 (Figure 15) was a short rainstorm with a few bursts of intense rainfall totaling 0.31 inch over five hours on November 26, 2017. As with Storm 7, Holloway x Jules was able to fully manage the storm. All blocks performed well. This storm provides a clear illustration of how the initial portion of a storm is absorbed by the storage within the GI facilities. As can be seen in the figure, no significant overflow occurred until the end of the storm when facility storage was exhausted on three of the blocks.

Figure 11: Hydrographs for small Storm 8 at Holloway x a) Jules, b) Faxon, c) Capitol, and d) Plymouth

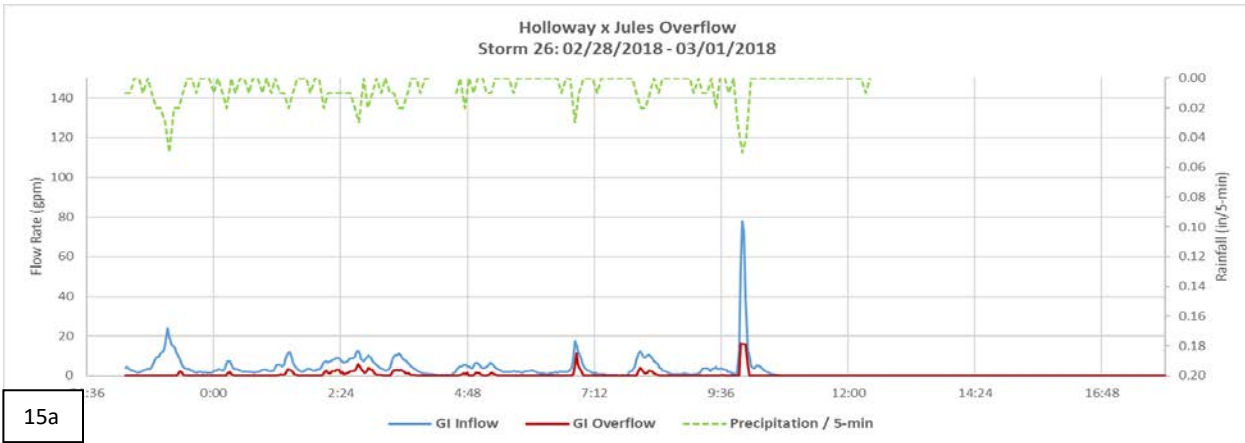
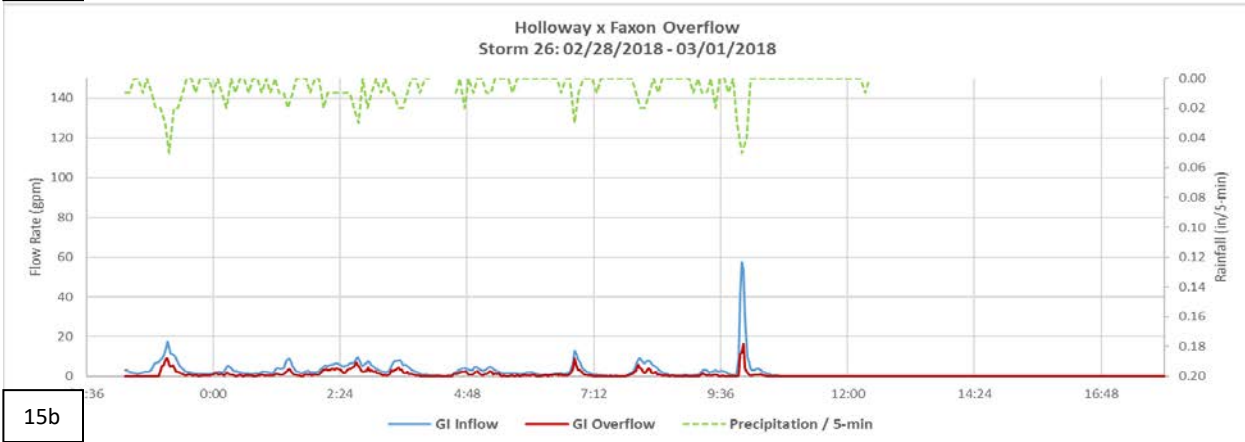
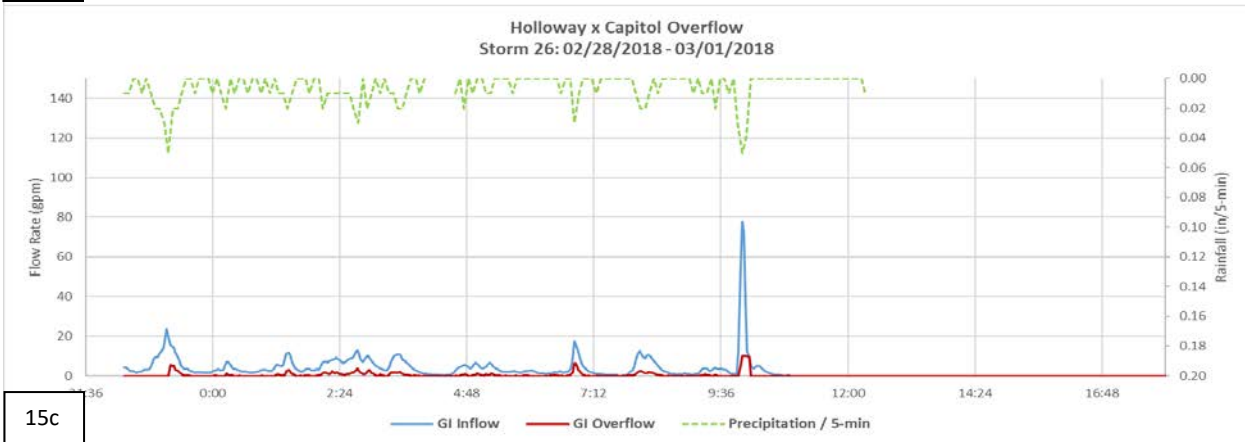
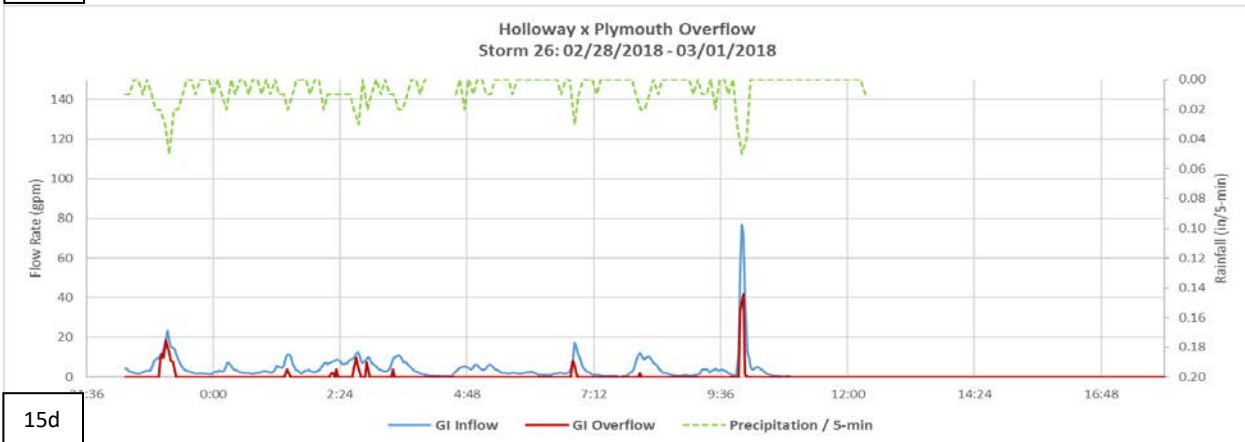
Storm 26 (Figure 16) represents a low-intensity storm with steady rainfall totaling 1.0 inch over the course of 14 hours starting on February 28, 2018. Even though this storm was the 4th largest of the monitoring period in terms of rainfall depth, performance exceeded the respective annual averages on each monitored block. There was a smaller storm two days earlier so the soil was partially saturated when this larger storm hit, which likely contributed to none of the blocks fully managing the storm. Still, the low-intensity nature of the storm is well suited to GI so both volume and peak flow reduction were above the annual average despite the larger rainfall volume.

Figure 12: Hydrographs for medium Storm 26 at Holloway x a) Jules, b) Faxon, c) Capitol, and d) Plymouth

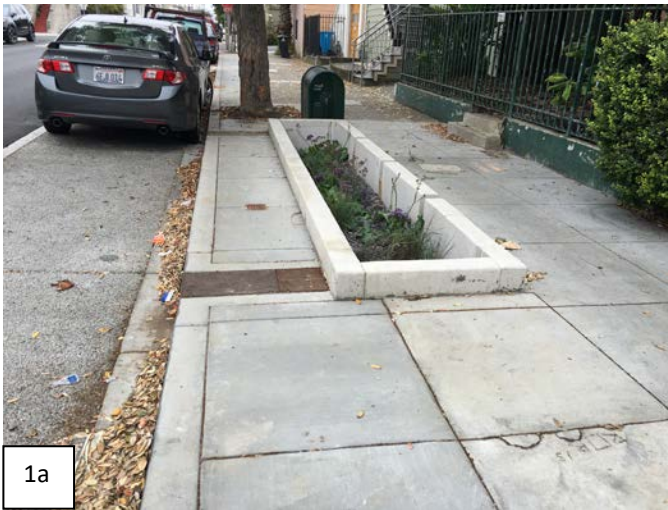
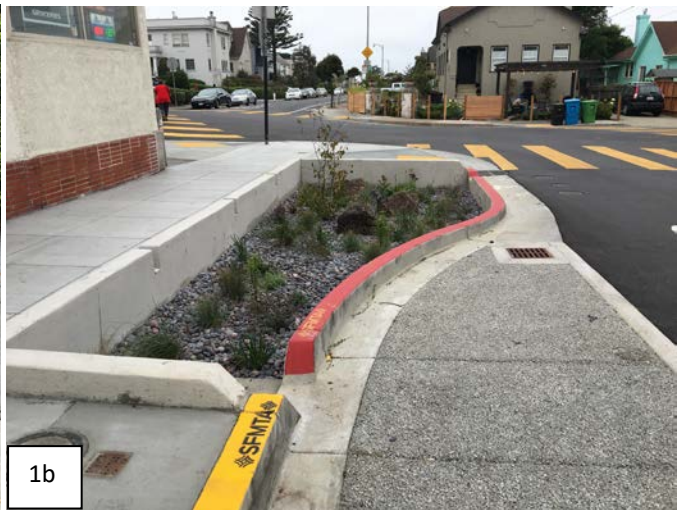
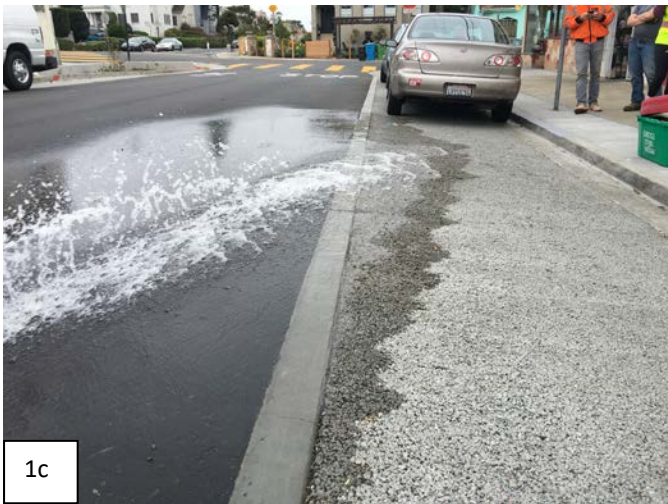
Figure 1a, 1b and 1c: A mid-block sidewalk planter, end-of-block bulbout planter, and pervious concrete.

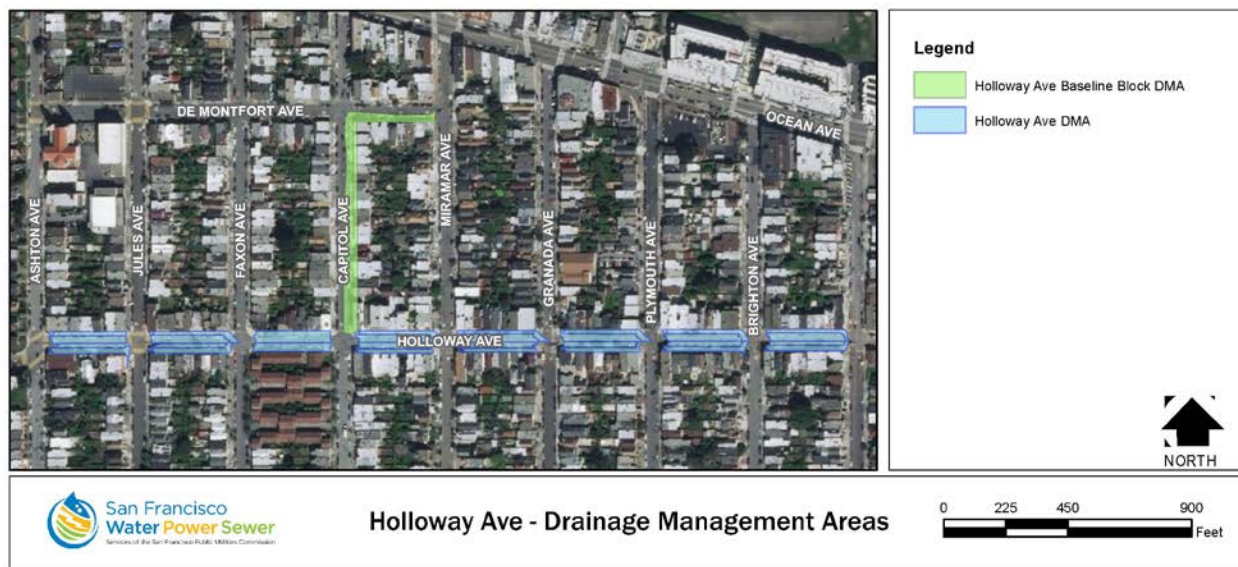
Figure 3: Location of the baseline block relative to the project area

Figure 3 shows the spatial relationship between the baseline block and the project area.

Table 1 provides the DMAs for both the baseline block and the monitored blocks, as well as the sizing ratio for the GI technologies. The baseline block DMA is larger than the project block DMAs because it is located on a corner where the two intersecting streets both drain to the catch basin. The DMAs were delineated using the subcatchment layer from the City and County of San Francisco (CCSF) Hydrologic and Hydraulic model and were then adjusted according to field observations of drainage patterns during wet conditions.

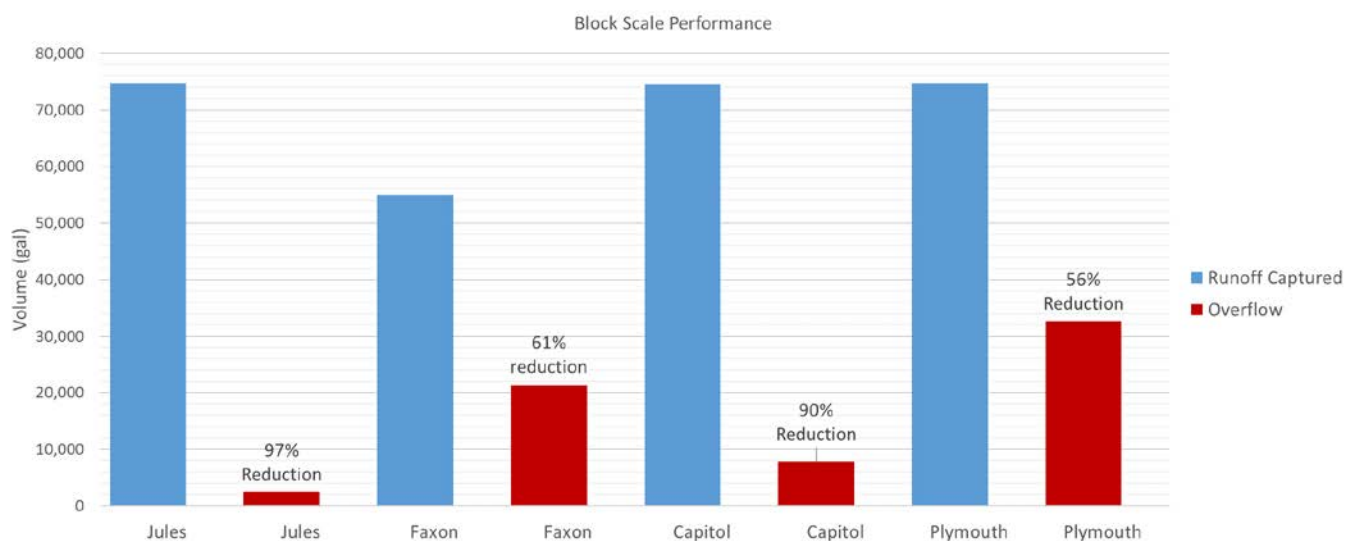
Overflow from the monitored blocks was significantly less than the baseline flow for all blocks. Measured across the whole rainy season, monitored volume reduction at the four blocks ranged from 56%-97% with an average 77%. Performance is strongly correlated to infiltration rate with the best performance at the western end of the project and generally decreasing to the east. The SWMM model was in general agreement with the monitoring results, estimating that GI reduced runoff volume by 83% across the four monitored blocks, and by 79% across the full project area. The SWMM model slightly oversimulated performance compared to the 2018-2019 monitoring results (83% modeled reduction versus 77% measured reduction for the four monitored blocks), while the 2017-2018 monitoring period slightly undersimulated performance (75% modeled reduction versus 78% measured). This may be a product of the porous media having slightly decreased infiltration capacity year over year due to deposition of fines in the pore space. According to both the monitoring results and the supporting modeling results, the overflow from the Model Block was significantly less than the baseline flow during the 2018-2019 monitoring period (Figure 8).

Figure 4: Monitored block performance for the 2018-2019 monitoring period.

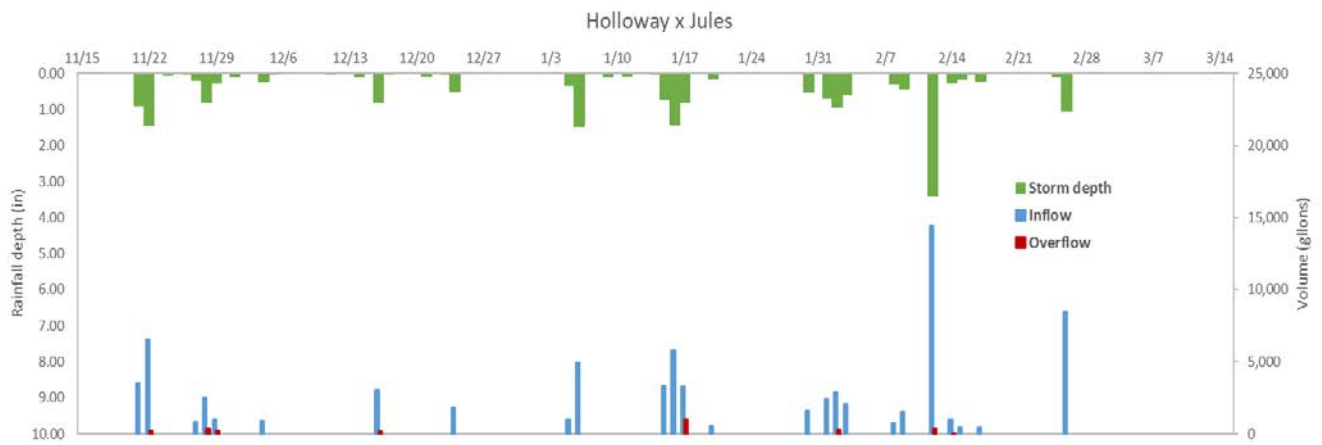
Figure 6: Hydrograph showing inflow and GI overflow of the 2018-2019 Monitoring Period at Holloway x Jules

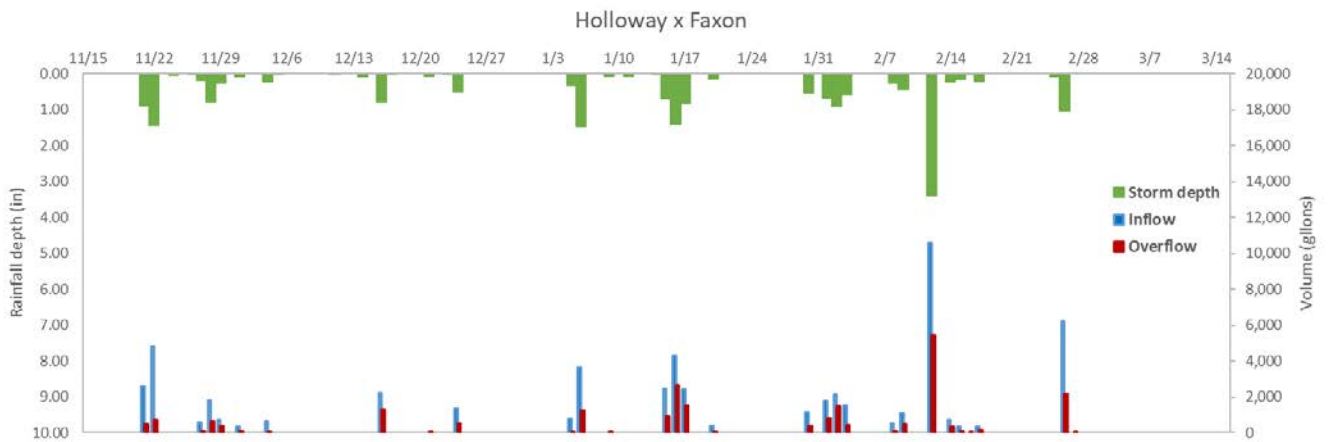
Figure 7: Hydrograph showing inflow and GI overflow of the 2018-2019 Monitoring Period at Holloway x Faxon

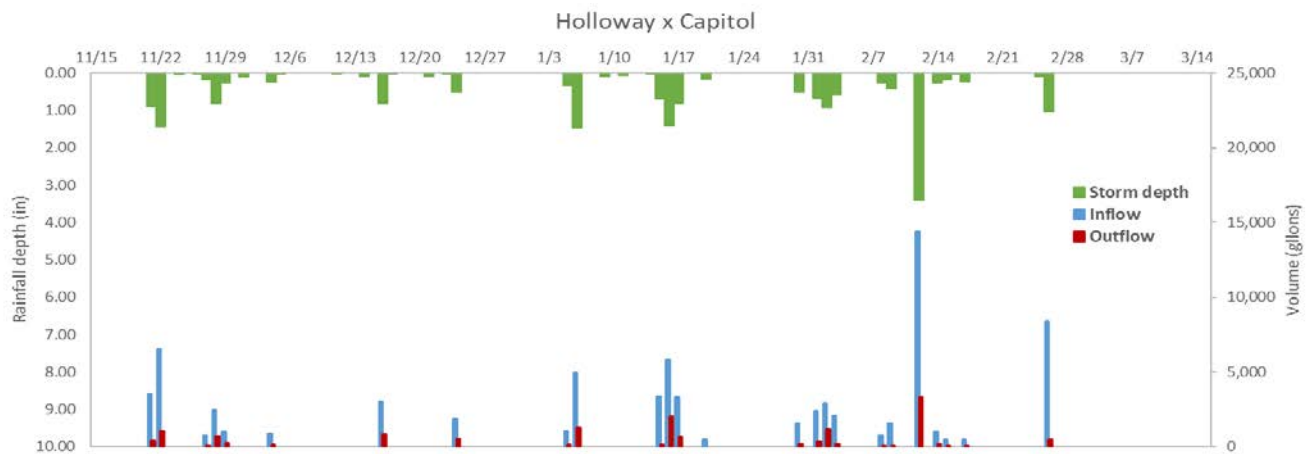
Figure 8: Hydrograph showing inflow and GI overflow of the 2018-2019 Monitoring Period at Holloway x Capitol

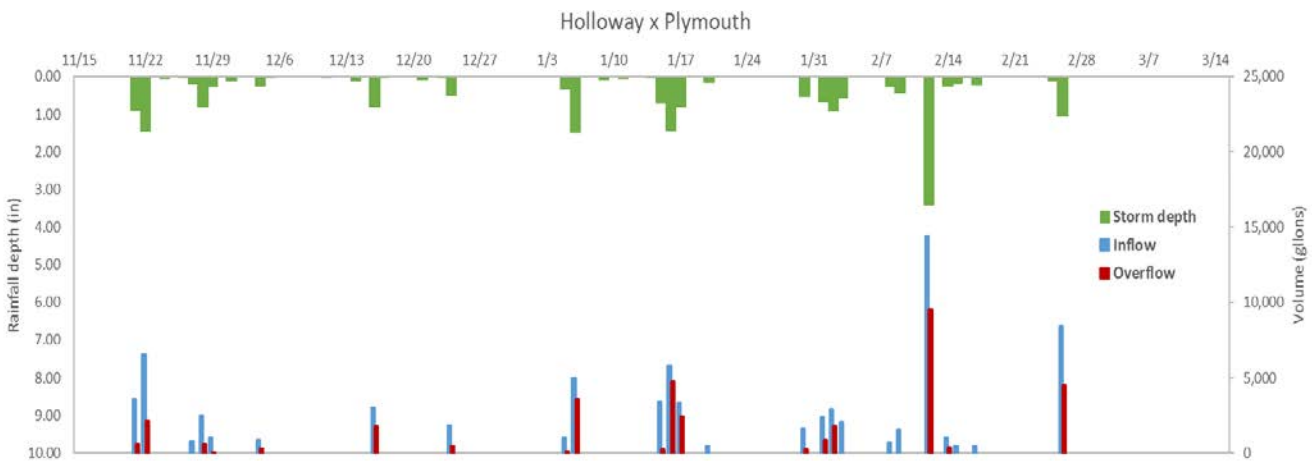
Figure 9: Hydrograph showing inflow and GI overflow of the 2018-2019 Monitoring Period at Holloway x Plymouth

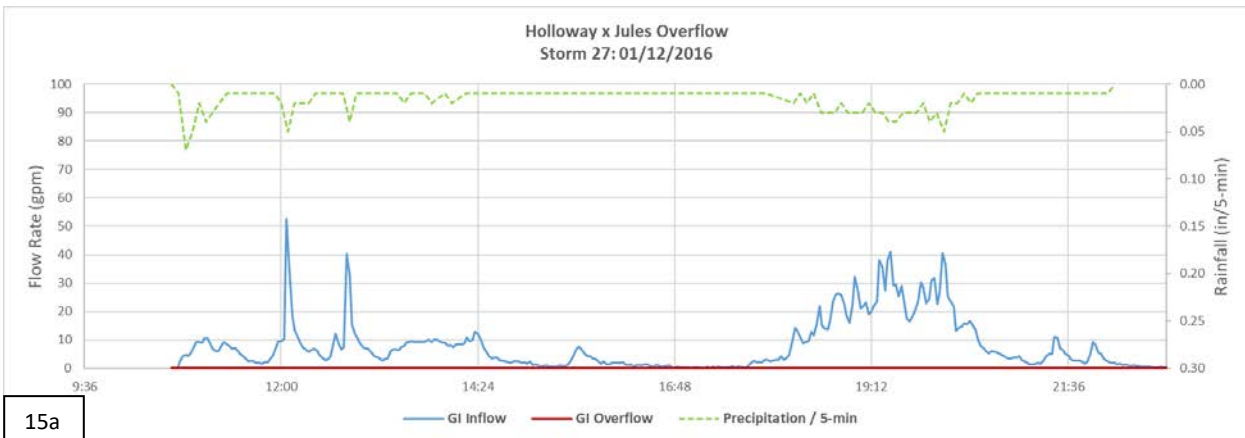
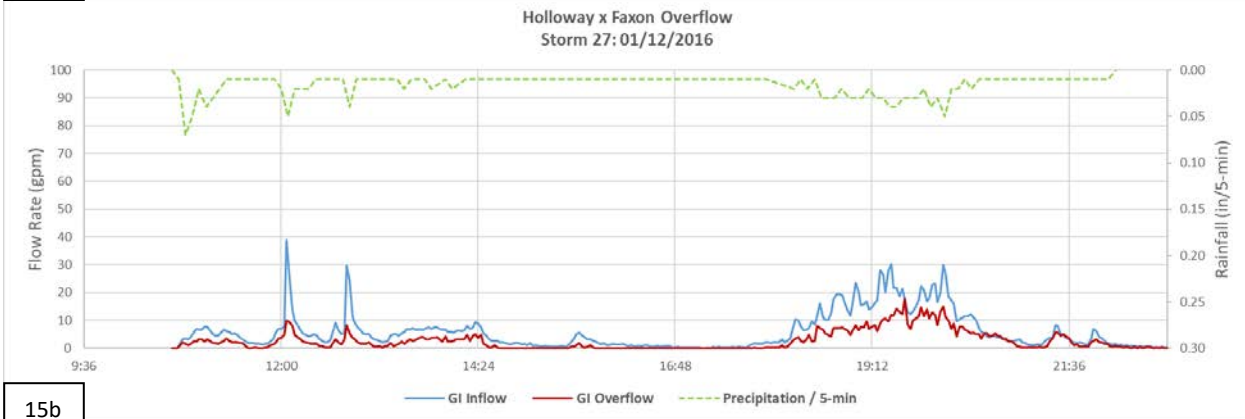
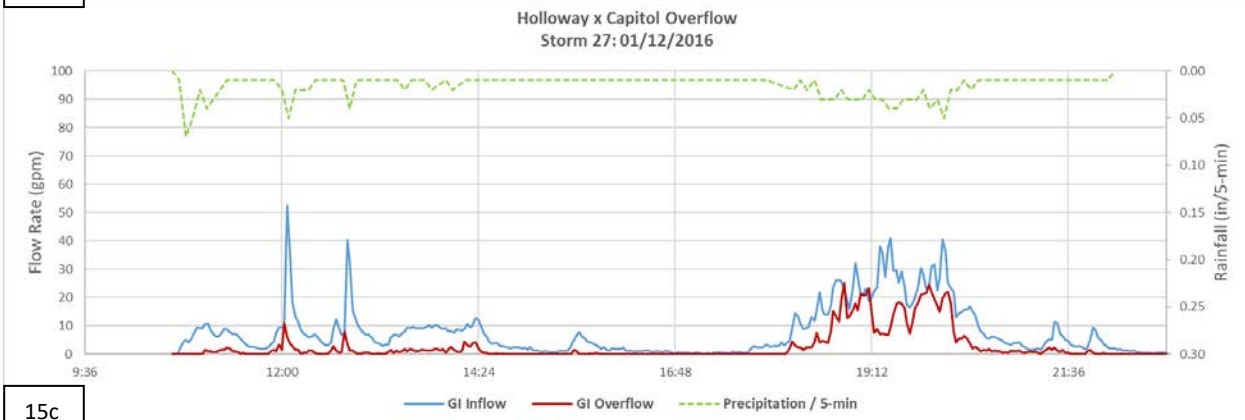
Figure 15 shows the hydrographs for a relatively large storm event on January 16th, 2019, Storm 27, which produced 1.42 inches of rainfall over the course of 11 hours, including an intense burst at the onset around noon and another later that evening. A moderate storm producing 0.7 inches of rain ended early that morning, so this was the second of a back-to-back storm. There was a wide range of monitored performance across the four blocks during this storm. Unlike Storm 25, which was smaller and less intense, most blocks were not able to fully manage this storm, the exception being Jules. Performance at Faxon was relatively consistent the whole time, hovering around the 59% reduction total for the storm, which reflects the active permeable pavement's ability to manage the vast majority of the runoff it receives. This storm provides a clear illustration of how the initial portion of a storm is absorbed by the storage within the GI facilities. Both Capitol and Plymouth performed better at the onset of the storm, then performance deteriorated as storage was exhausted. Capitol absorbed most of the first burst and the ensuing low-intensity rainfall until around 7:00 PM when storage was overwhelmed by the second burst. Plymouth has the poorest draining soils and, given the wet antecedent soil conditions, was only able to absorb the initial portions of each burst and then entered a flow-through condition.

Figure 11: Hydrographs for Storm 27 at Holloway x a) Jules, b) Faxon, c) Capitol, and d) Plymouth

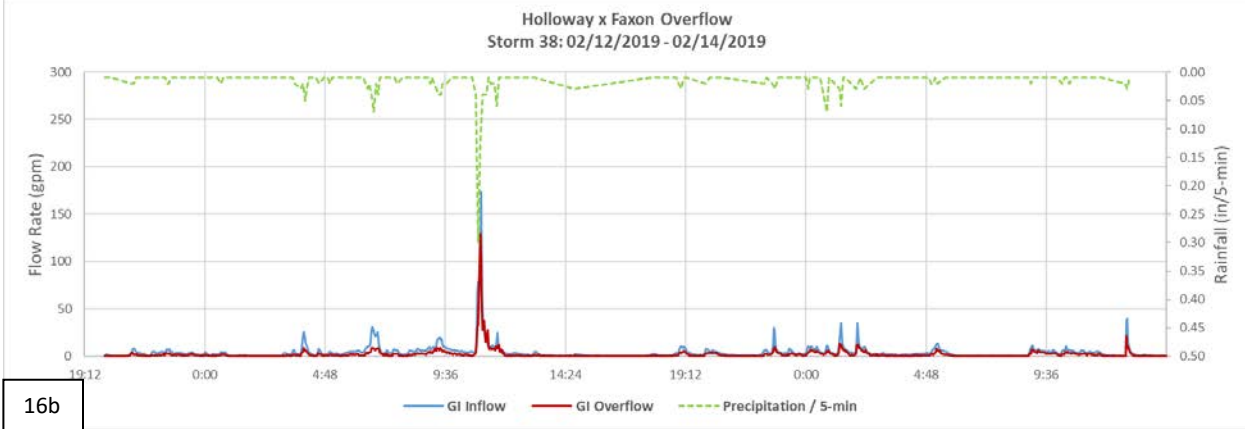
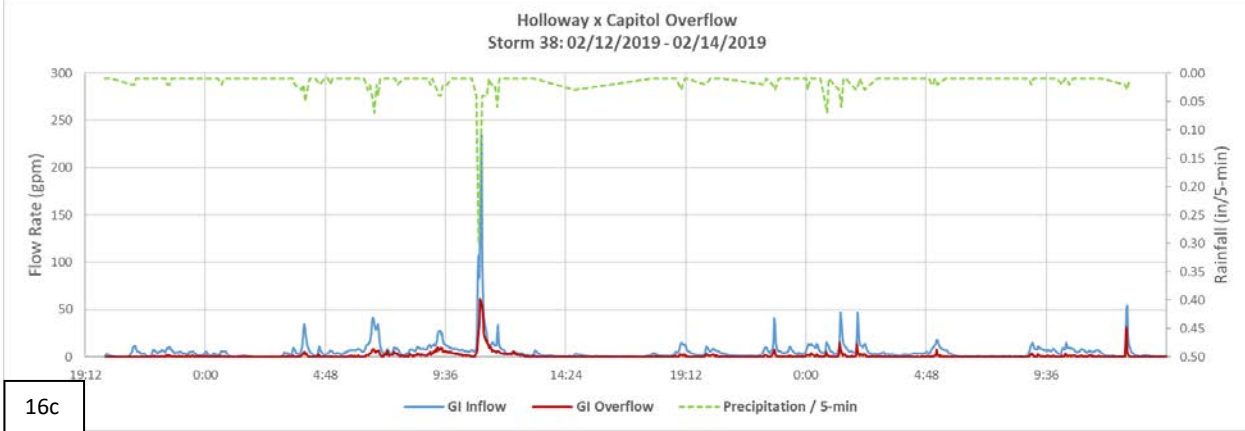
Storm 38 (Figure 16) was the largest storm of the monitoring period and also contained the most intense burst. It had been almost three days since the previous storm, so all facilities started out with ample storage. The storm lasted almost two days with a total depth of 3.4 inches, including 0.58 inch over a 30-minute period late in the morning on February 13th. As with Storm 27, there was a wide range of monitored performance across the four blocks. None of the blocks were able to fully manage the storm. Jules managed virtually the entire storm outside of the one huge burst, reducing overall volume by 96% and significantly dampening the peak flow. Capitol also performed well, significantly reducing volume by 86% and dampening peak flows. As with most storms, Faxon performed consistently, but was overwhelmed by the large burst. The storage at Plymouth was exhausted around eight hours into the storm, and GI on this block was not effective in managing most subsequent flows by either measure of volume or peak flow.

Figure 12: Hydrographs for Storm 38 at Holloway x a) Jules, b) Faxon, c) Capitol, and d) Plymouth
